Ethernet Routing Switch 5000 Series Software Release 6.3.2

1. Release Summary

Purpose: Software patch release to address customer and internally found software issues.

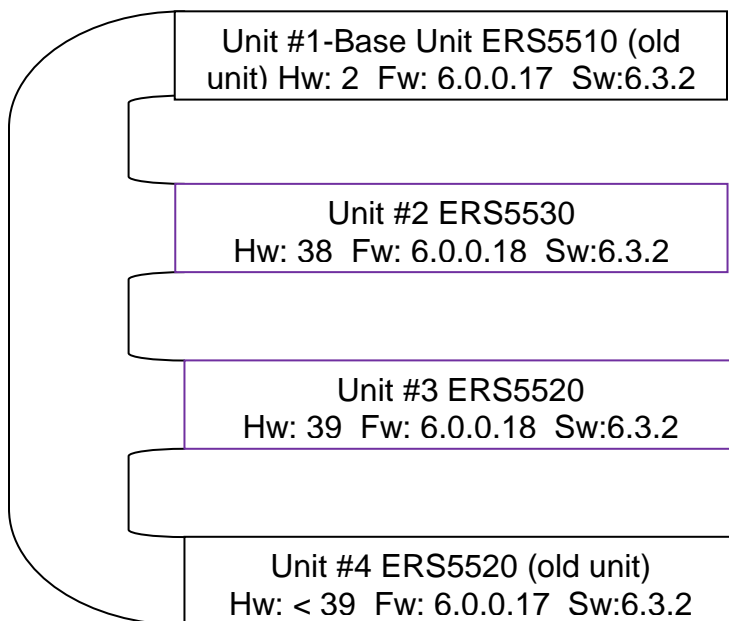
When performing image agent downgrade, if BU has a diagnostic image prior to 6.0.0.18 and **new units** are in the stack, no agent image downgrade will be performed and the following error message will be displayed:

`"% Software downgrade not supported. BU has older diagnostic."`

Figure 2: No agent image downgrade will be allowed for this stack, BU has an older diagnostic (prior to 6.0.0.18) version and **new units** are in stack.

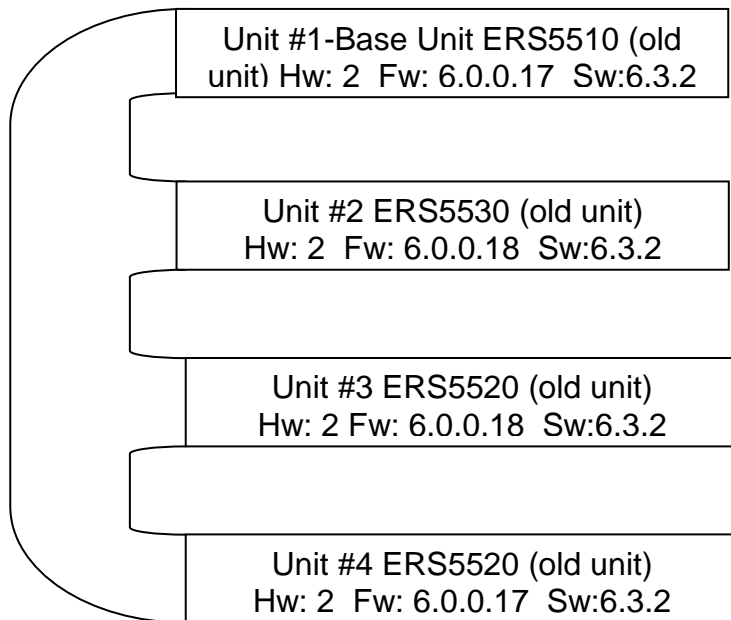
When performing image agent downgrade, if BU has a diagnostic image prior to 6.0.0.18 and there are no **new units** in the stack, the agent image downgrade will be performed.

Figure 3: Agent image downgrade will be allowed for this stack even if BU has an older diagnostic (prior to 6.0.0.18) and there are no **new units** in the stack.

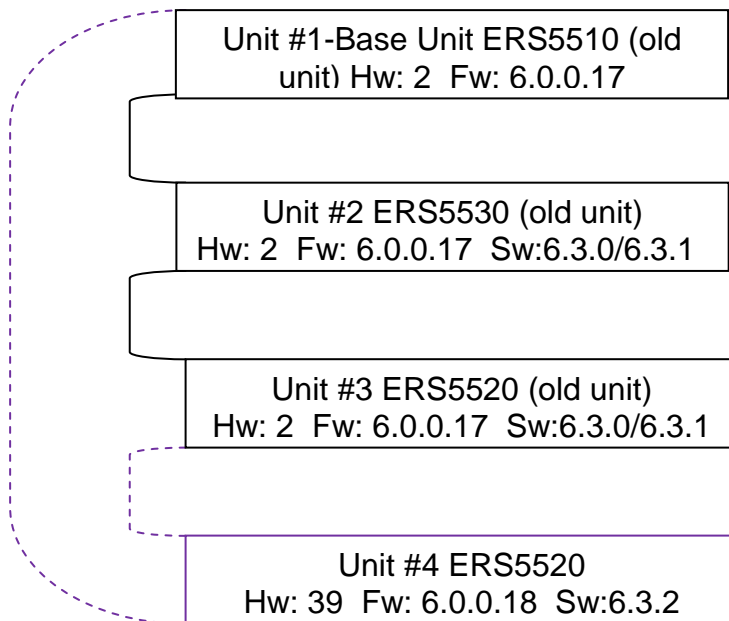
When **new units** are added to a stack with DAUR running, older agent images (6.3.0 or 6.3.1) won't transfer the agent image if the BU's diagnostic isn't 6.0.0.18 or newer.

"AAUR - The hardware is not compatible with stack diagnostic %s version"

Figure 4: A **new unit** running SW 6.3.2 added to a stack running an older agent image that supports DAUR won't transfer the image if the BU diagnostic is not 6.0.0.18 or newer.

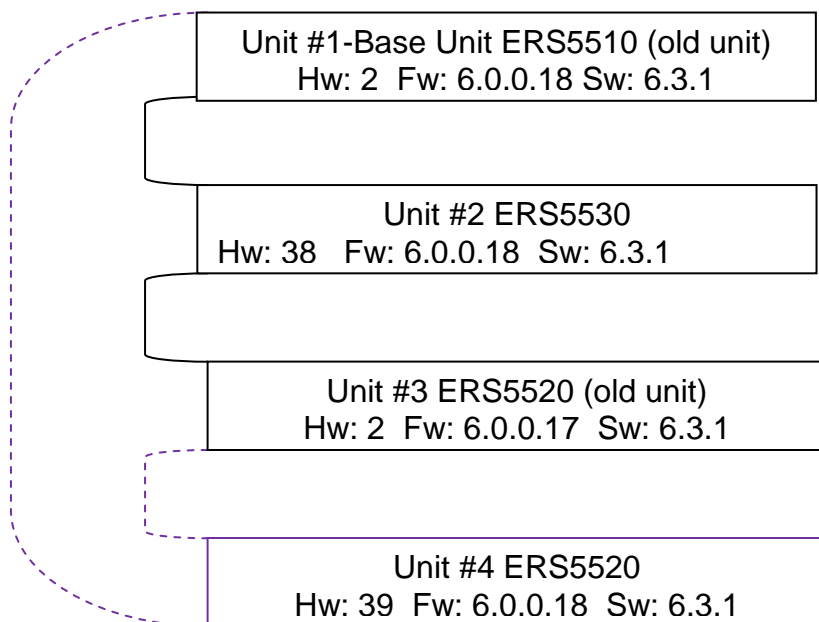
-**Step 1:** Downgrade previous 6.3.2 SW agent images on a 6.3.2 stack having **new units**

Figure 9: A stack with SW prior to 6.3.2 and base unit diagnostic firmware 6.0.0.18
